SOLID WASTE / ENVIRONMENTAL MANAGEMENT PROJECT

**HBALINE (JBEIL)
LANDFILL PROJECT**

**GEOTECHNICAL
SITE INVESTIGATION
REPORT**

August 2001

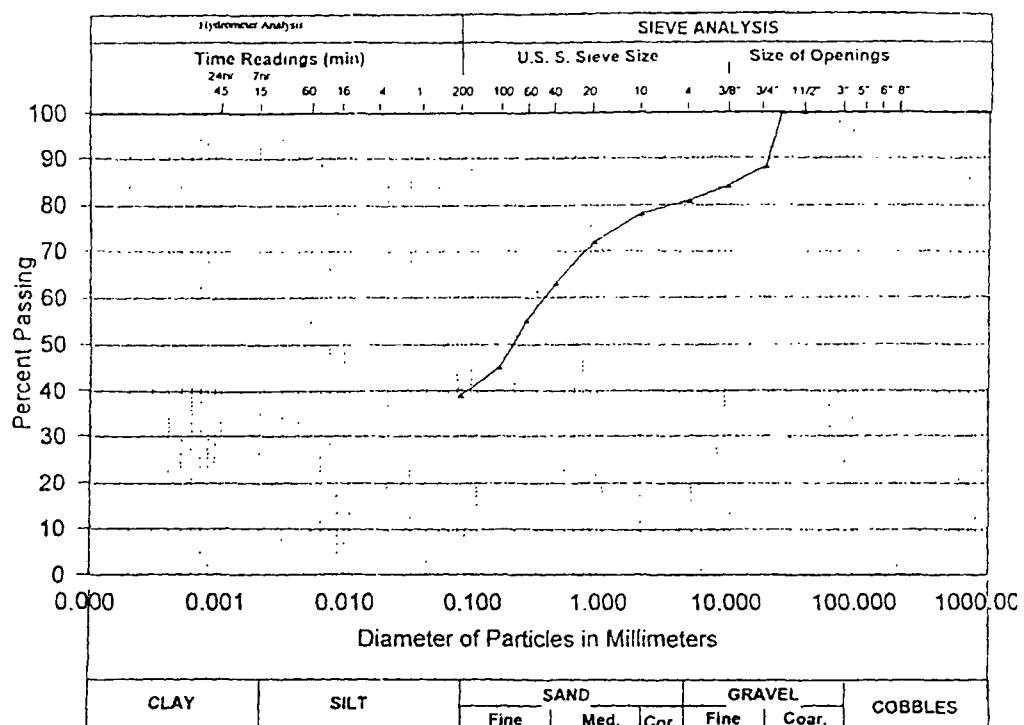
Project No.	G2K1031	HBALINE LANDFILL LIBAN CONSULT	Boring #
TOUMA ENGINEERING			Sample # TP-2 depth = -3.00~ Ref : F1

PARTICLE SIZE ANALYSIS

Moisture Content (%)	Depth B.G.S. (m)	Gs	ASTM Class.	LL (%)	PL (%)	PI (%)
19.43	3	N/A	SC	31	20	11

Sieve Size	3/4"	3/8"	#4	#10	#40	#100	#200"
% Passing	88	84	81	78	63	45	39

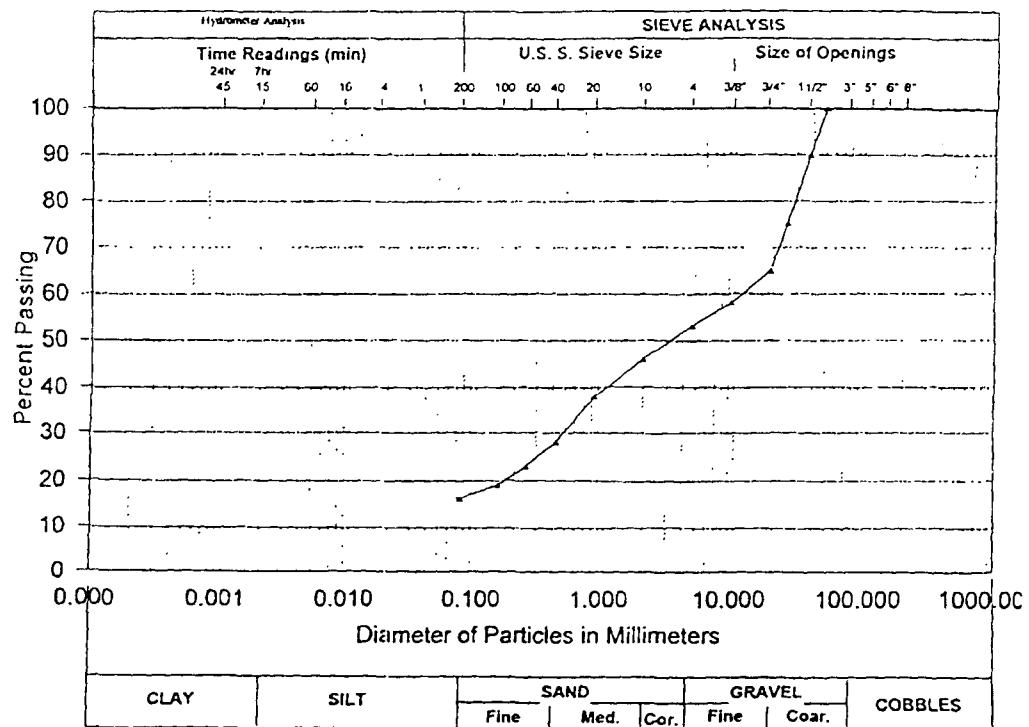
Project No.	G2K1031	HBALINE LANDFILL	Boring #
TOUMA		LIBAN CONSULT	Sample #
ENGINEERING			TP-2 depth - 5.00 m Ref : F2

PARTICLE SIZE ANALYSIS

Moisture Content (%)	Depth B.G.S. (m)	Gs	ASTM Class. GC	LL (%)	PL (%)	PI (%)
6.41	5	N/A		29	20	9

Sieve Size	3/4"	3/8"	#4	#10	#40	#100	#200
% Passing	65	58	53	46	28	19	16

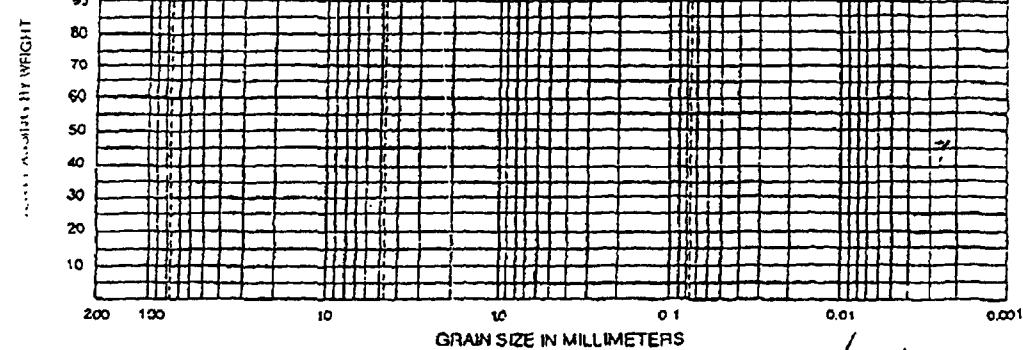
F4

SIEVE ANALYSIS

PROJECT: HABALINE LAND FILL : المتنع
 CLIENT: : العميل
 MATERIAL DESCRIPTION: light brown clayey GRAVEL
with sand

LL = 29PL = 20PI = 9CLASSIFICATION CuC

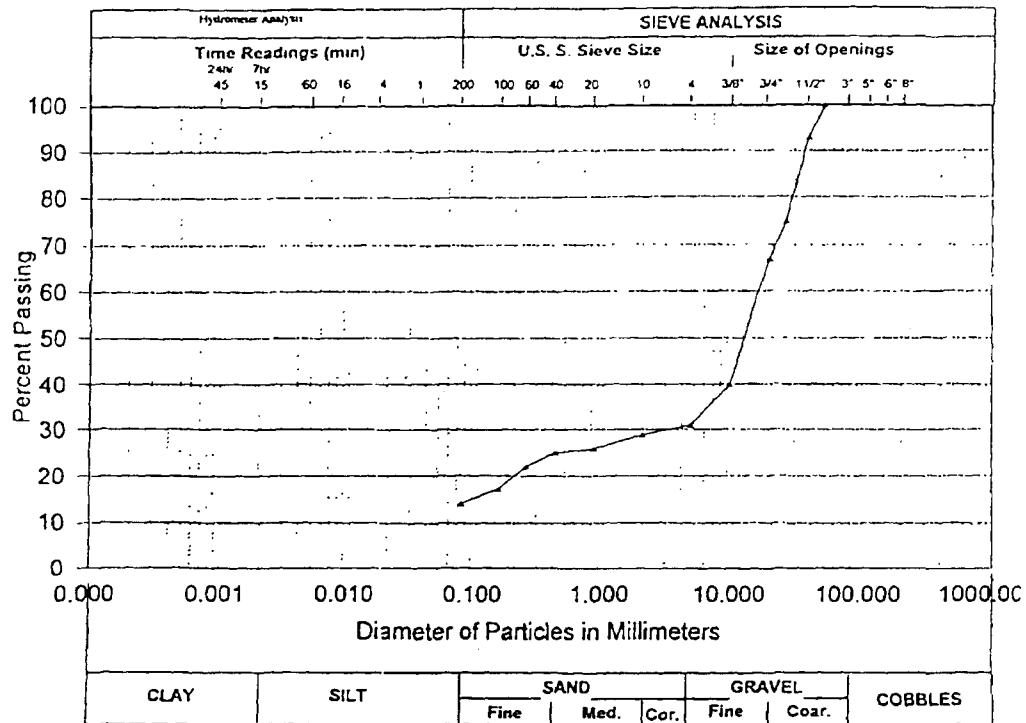
Project No.	G2K1031	HEALINE LANDFILL	Boring #
TOUMA		LIBAN CONSULT	Sample # TP-3
ENGINEERING			Ref: F3

PARTICLE SIZE ANALYSIS

Moisture Content (%)	Depth B.G.S. (m)	Gs	ASTM Class.	LL (%)	PL (%)	PI (%)
7.48	2	N/A	GC	27	18	9

Sieve Size	3/4"	3/8"	#4	#10	#40	#100	#200"
% Passing	67	40	31	29	25	17	14

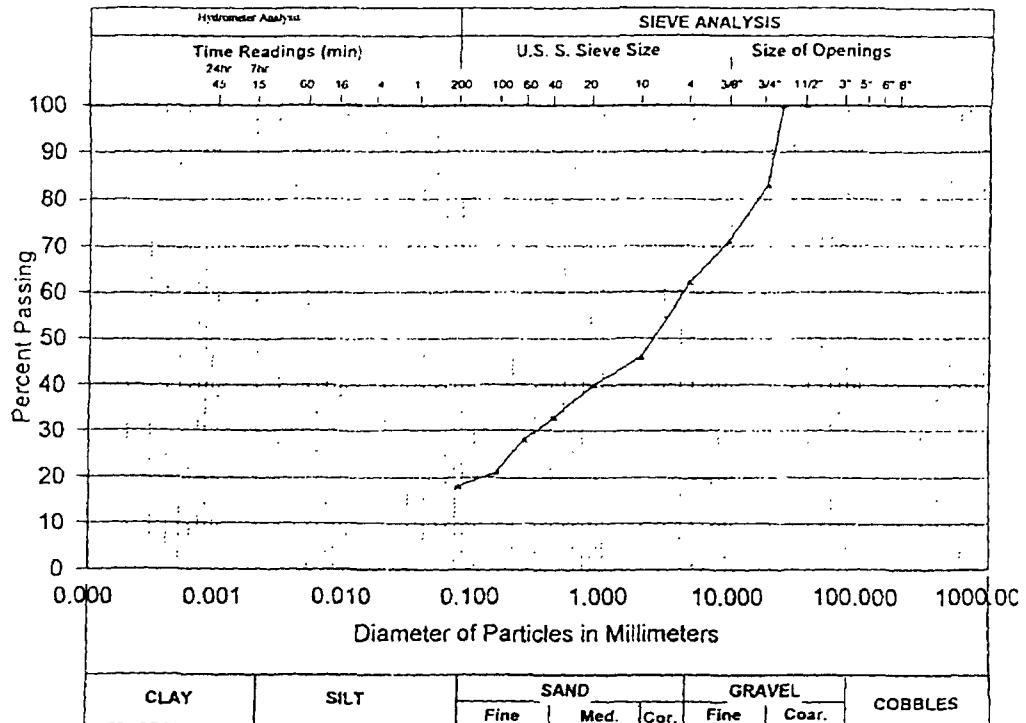
PARTICLE SIZE ANALYSIS

Moisture Content (%)	Depth B.G.S. (m)	Gs	ASTM Class.	LL (%)	PL (%)	PI (%)
7.6	4	N/A	SC-SM	20	14	6

Sieve Size	3/4"	3/8"	#4	#10	#40	#100	#200*
% Passing	83	71	62	46	33	21	18

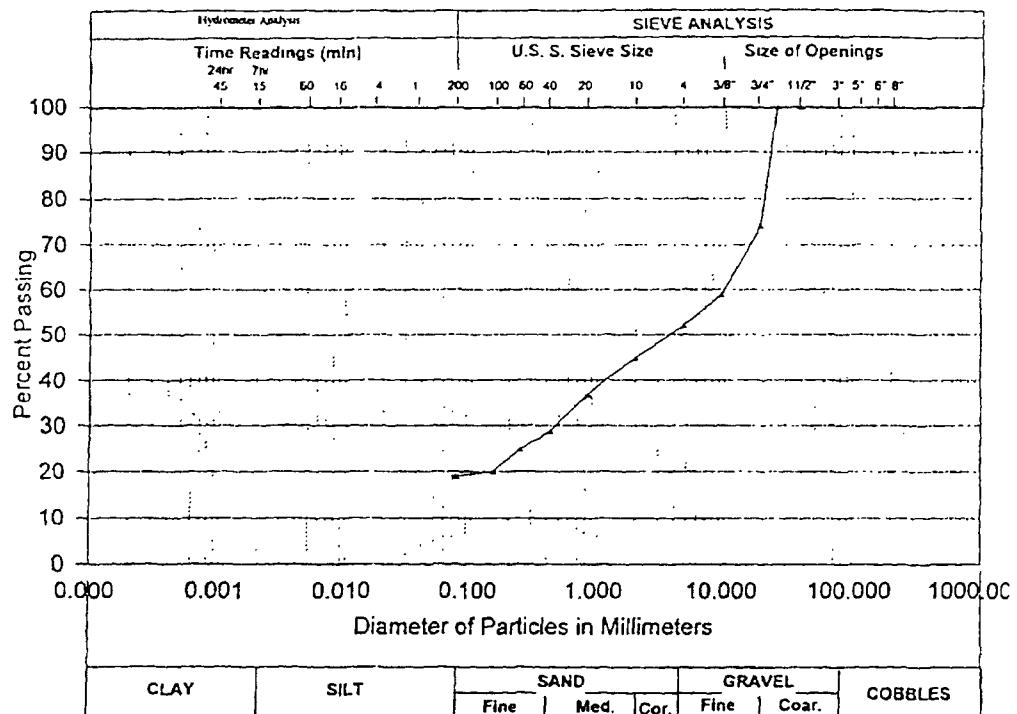
PARTICLE SIZE ANALYSIS

Moisture Content (%)	Depth B.G.S. (m)	Gs	ASTM Class.	LL (%)	PL (%)	PI (%)
8.235	N/A	GC-GM		19	14	5

Sieve Size	3/4"	3/8"	#4	#10	#40	#100	#200"
% Passing	74	59	52	45	29	20	19

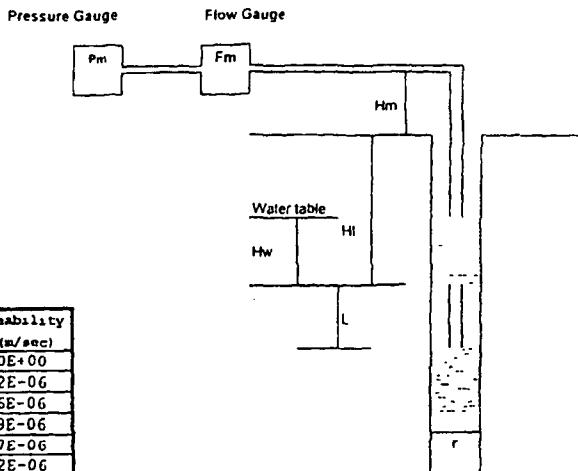
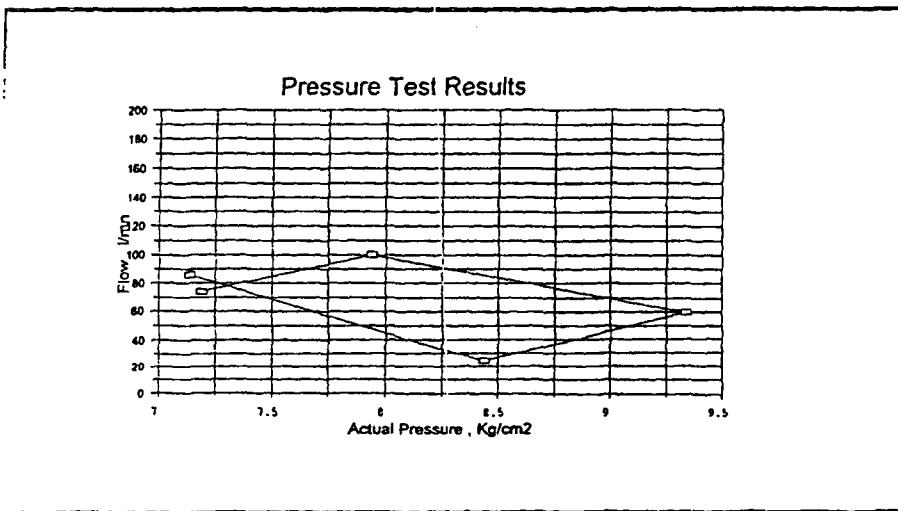
Graph No: 1

Permeability Testing Results
Hbaline Landfill - Liban Consult

BH no:	3
Test no:	1
Ht (m)	63
Hw (m)	0
Hm (m)	1.65
ϵ (m)	0.05
L (m)	1.5

Pm Readings (kg/cm ²)	Flow (l/min)	Press Losses (kg/cm ²)	Actual Press (kg/cm ²)	Permeability K: (m/sec)
0.00	0.0	0	6.47	0.0E+00
1.00	74.0	0.35	7.19	6.2E-06
2.00	100.0	0.6	7.94	7.6E-06
3.00	60.0	0.2	9.34	3.9E-06
2.00	24.0	0.1	8.44	1.7E-06
1.00	86.0	0.4	7.14	7.2E-06

Les essais lugeons ont donné un coefficient de perméabilité moyenne de $5 \cdot 10^{-6}$ m/s à des profondeurs supérieures à 45 mètres, cette perméabilité est considérée comme une valeur moyenne entre les matériaux étanches et les plus perméables. Elle nécessite un traitement supplémentaire pour garantir l'étanchéité du site contre toute infiltration de lixiviats. Le traitement consisterait en une couche d'argile de 50 à 60 cm, une géomembrane, avec les protections géotextile nécessaires. L'installations d'une double géomembrane (au lieu d'une) nous paraît excessif en égard à la mise d'une couche d'argile d'épaisseur suffisante et au fait, qu'à ce jour et sans aucune protection aucun cheminement de lixiviats n'a pu atteindre le nappe depuis une vingtaine d'années

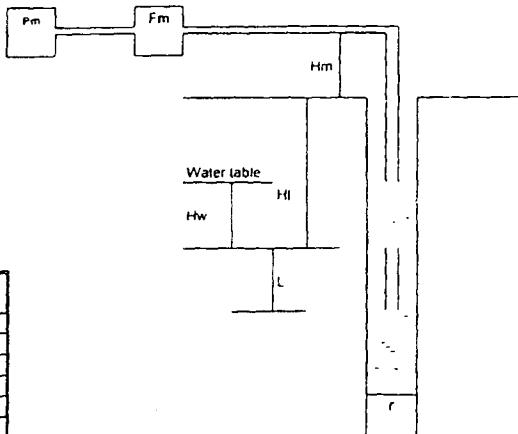
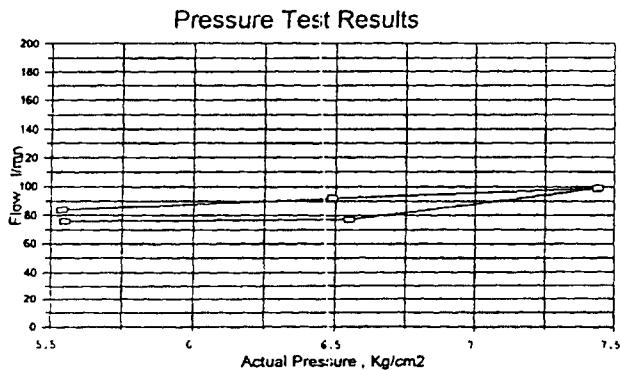
Graph No: 2

Permeability Testing Results
Hhaline Landfill - Liban Consult

B.H.no:	3
Test no.:	2
Ht (m)	45
Hw (m)	0
Hm (m)	1.65
r (m)	0.05
L (m)	1.5

Pm Readings (kg/cm ²)	Flow (l/min)	Press Losses (Kg/cm ²)	Actual Press (Kg/cm ²)	Permeability K: (m/sec)
0.00	0.0	0	4.67	0.0E+00
1.00	84.0	0.2	5.54	9.1E-06
2.00	92.0	0.25	6.49	8.5E-06
3.00	99.0	0.3	7.44	8.0E-06
2.00	77.0	0.19	6.55	7.1E-06
1.00	76.0	0.19	5.55	8.2E-06

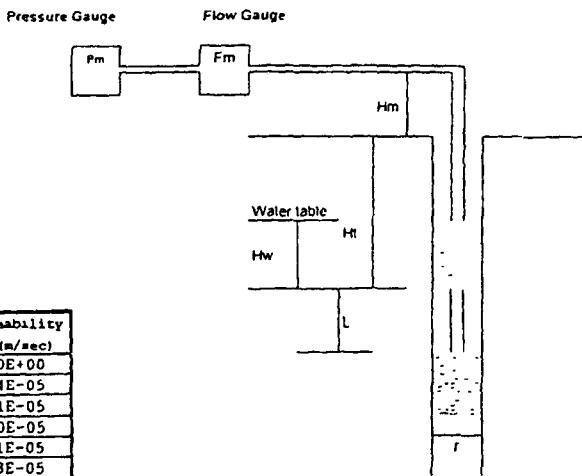
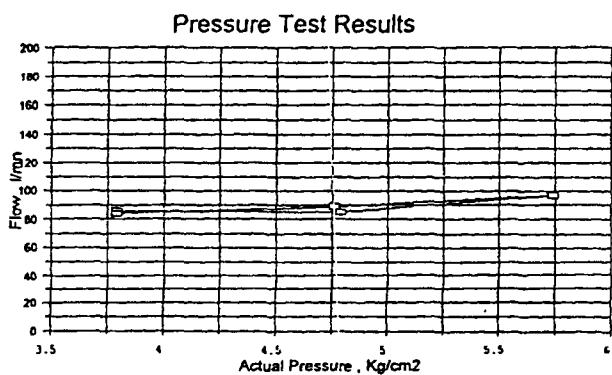
Graph No: 3

Permeability Testing Results Hbaline Landfill - Liban Consult

L.H.no	3
Test no:	3
H _L (m)	27
H _w (m)	0
H _m (m)	1.65
c (m)	0.05
L (m)	1.5

Pm Readings (kg/cm ²)	Flow (l/min)	Press Losses (kg/cm ²)	Actual Press (kg/cm ²)	Permeability K; (m/sec)
0.00	0.0	0	2.87	0.0E+00
1.00	86.0	0.15	3.79	1.4E-05
2.00	85.0	0.15	4.79	1.1E-05
3.00	97.0	0.2	5.74	1.0E-05
2.00	89.0	0.18	4.76	1.1E-05
1.00	84.0	0.15	3.79	1.3E-05
